PLAY AREA SAFETY INSPECTION REPORT

Site Owner : **Parish Councils**
Site Name : Goldsborough Play Area
Date of Inspection : 02 October 2018
Inspected by : David Owen

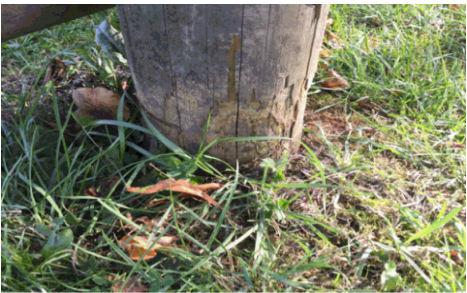
Adventure Trail - Square
Playdale Playgrounds Ltd

Comments, action or control required		Risk Level	Risk Score ‡
Equipment			
Finding :	Strimmer damage to supports is likely to accelerate timber rot.	Low	5
Finding Date :	02/10/2018		
Task :	Prevent further damage.

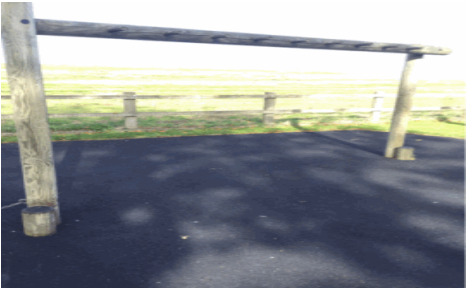
Agility Unit - Trapeeze & Tyre Walk

Comments, action or control required		Risk Level	Risk Score ‡
Equipment			
Finding : RoSPA is concerned by accidents on some types of overhead ladders and rings . There is, however, a strong development value in these items. Finding Date : 02/10/2018

Low	5	
Task : The protective surface under all bars and rings must be kept in good condition. Finding : There are natural splits/shakes in the timbers. Finding Date : 02/10/2018

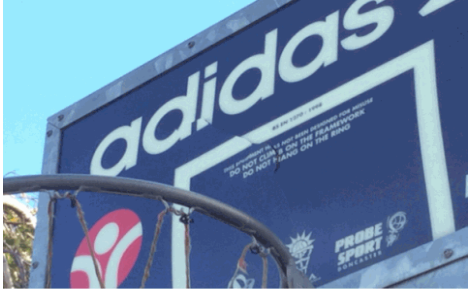
Basketball Post

Comments, action or control required		Risk Level	Risk Score ‡
Equipment			
Finding :	Item - Cracked	Low	5
Finding Date :	02/10/2018		
Notes :	Backboard is cracked . Repair

Task :	Repair item		
Surfacing - Tarmac			
No remedial maintenance work is required at this time.			
The overall risk for this item at the time of inspection:		Medium	8
‡ For Risk Score see Report Notes

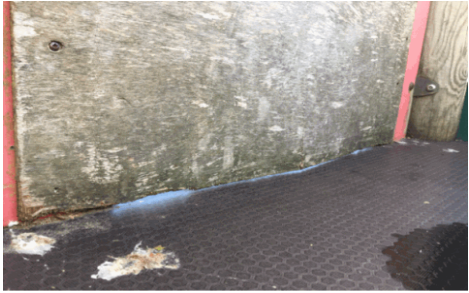
Multiplay - Junior - With Slide

Comments, action or control required		Risk Level	Risk Score ‡
Equipment			
Finding : Delamination of Wood Finding Date : 02/10/2018 Notes : Temporary barrier board is delaminating and flexing. Replace with a more substantial piece of boarding.

Low	6
Task : Remove damaged wood Finding : Item - Cap missing Finding Date : 02/10/2018

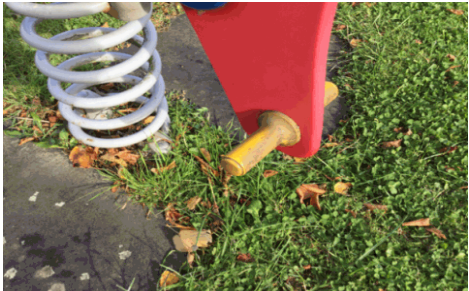
Rocker - Horse

Comments, action or control required		Risk Level	Risk Score ‡
Equipment			
Finding : Protruding handles/footrests		Very Low	3
Finding Date : 02/10/2018			
Task : No Action Required

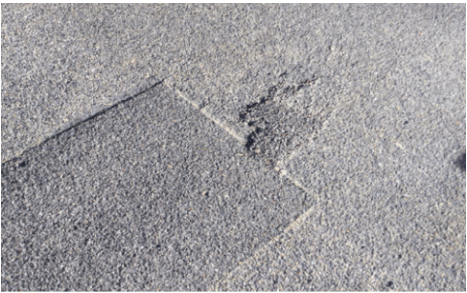
Swing - Junior - 1 Bay 2 Seat

Comments, action or control required		Risk Level	Risk Score ‡
Equipment No remedial maintenance work is required at this time.			
Surfacing - Wet Pour			
Finding : Surface - Needs Repair Finding Date : 02/10/2018 Notes : Surface wearing. Repair

Low	6
Task : Repair surface Finding : Surface - Slippery Finding Date : 02/10/2018 Notes : Surface becoming slippery. Clean.

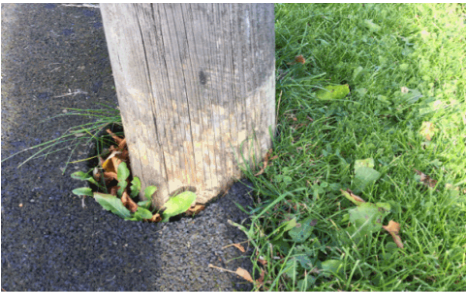
Swing - Toddler - 1 Bay 2 Seat

Comments, action or control required		Risk Level	Risk Score ‡
Equipment			
Finding :	Timber - Strimmer Damage	Low	5
Finding Date :	02/10/2018

Task :	Notify grounds maintenance staff		
Finding :	There are natural splits/shakes in the timbers.	Low	5
Finding Date :	02/10/2018
