PLAY AREA SAFETY INSPECTION REPORT

Site Owner : **Parish Councils**
Site Name : Goldsborough Play Area
Date of Inspection : 02 October 2018
Inspected by : David Owen

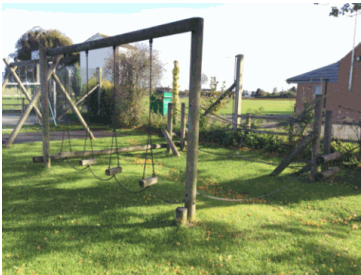
Adventure Trail - Square
Playdale Playgrounds Ltd

Risk Level : Low
Risk Score : 4

Comments, action or control required		Risk Level	Risk Score ‡
Equipment			
Finding :	Strimmer damage to supports is likely to accelerate timber rot.	Low	5
Finding Date :	02/10/2018		
Task :	Prevent further damage.

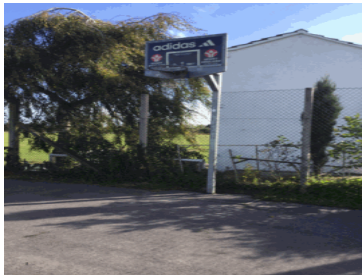
Basketball Post

Risk Level : Medium

Risk Score : 8

Comments, action or control required		Risk Level	Risk Score ‡
Equipment			
Finding :	Item - Cracked	Low	5
Finding Date :	02/10/2018		
Notes :	Backboard is cracked . Repair

Task :	Repair item		
Surfacing - Tarmac			
No remedial maintenance work is required at this time.			
The overall risk for this item at the time of inspection:		Medium	8
‡ For Risk Score see Report Notes

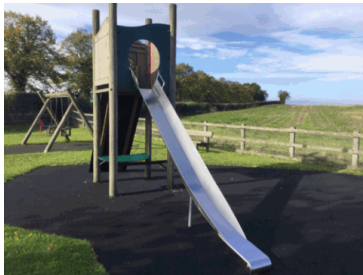
Multiplay - Junior - With Slide

Risk Level : Low
Risk Score : 5

The item fails to meet the requirement of the relevant standard.

Comments, action or control required		Risk Level	Risk Score ‡
Equipment			
Finding : Delamination of Wood Finding Date : 02/10/2018 Notes : Temporary barrier board is delaminating and flexing. Replace with a more substantial piece of boarding.

Low	6
Task : Remove damaged wood Finding : Item - Cap missing Finding Date : 02/10/2018

Low	5
Task : Replace item			
Surfacing - Wet Pour			
No remedial maintenance work is required at this time.			
The overall risk for this item at the time of inspection: ‡ For Risk Score see Report Notes		Low	6

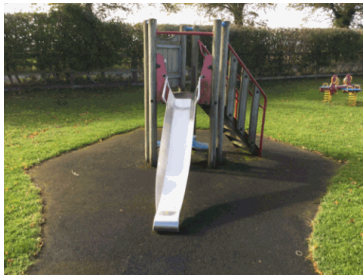
Multiplay - Toddler - With Slide

Risk Level : Low

Risk Score : 4

Comments, action or control required		Risk Level	Risk Score ‡
Equipment			
Finding : Item - Cap missing Finding Date : 02/10/2018   Task : Replace item		Low	4
Surfacing - Wet Pour			
No remedial maintenance work is required at this time.		Low	4
The overall risk for this item at the time of inspection: ‡ For Risk Score see Report Notes		Low	4

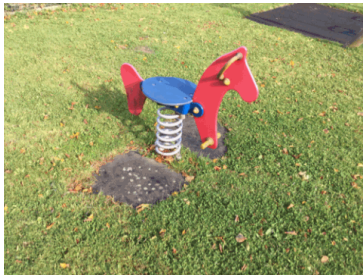
Rocker - Horse

Risk Level : Very Low

Risk Score : 3

The item fails to meet the requirement of the relevant standard.

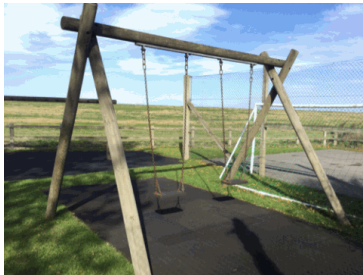
Swing - Junior - 1 Bay 2 Seat

Risk Level : Low
Risk Score : 4

Comments, action or control required		Risk Level	Risk Score ‡
Equipment No remedial maintenance work is required at this time.			
Surfacing - Wet Pour			
Finding : Surface - Needs Repair Finding Date : 02/10/2018 Notes : Surface wearing. Repair

Low	6
Task : Repair surface Finding : Surface - Slippery Finding Date : 02/10/2018 Notes : Surface becoming slippery. Clean.

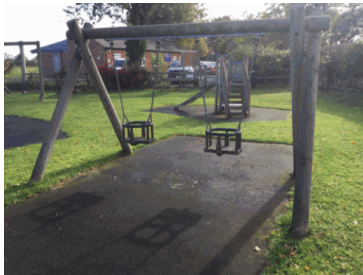
Swing - Toddler - 1 Bay 2 Seat

Risk Level : Very Low

Risk Score : 3

Comments, action or control required		Risk Level	Risk Score ‡
Equipment			
Finding :	Timber - Strimmer Damage	Low	5
Finding Date :	02/10/2018
